## STRUCTURAL DESIGN CERTIFICATE

**Project Description: Design Quintessence Boom Arms**

## LOAD TEST REPORTS

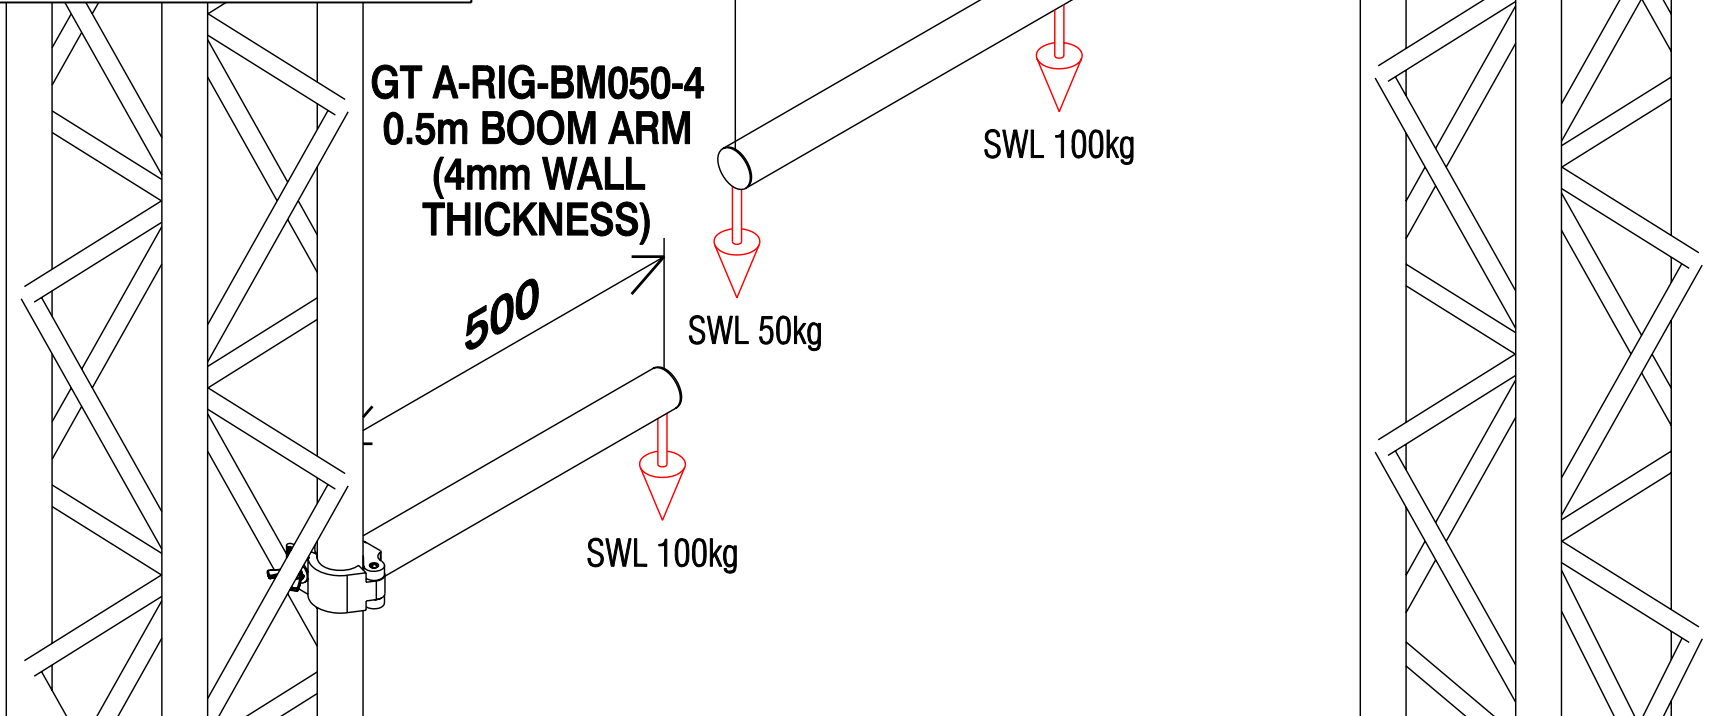
**GT A-RIG-BM050-4  
0.5m BOOM ARM  
(4mm WALL THICKNESS)**

DRAWING:  
**4mm WALL BOOM ARM LOAD POINT INFORMATION**

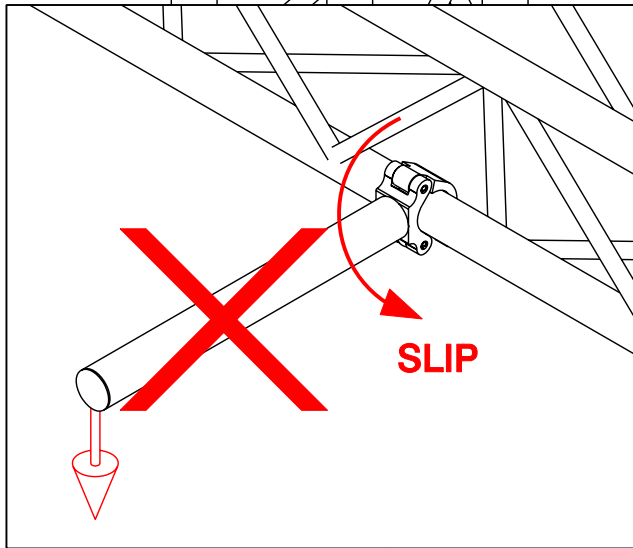
DRAWING No.:  
417/036

**GT A-RIG-BM100**  
**1.0m BOOM ARM**  
**(3mm WALL THICKNESS)**

**GT A-RIG-BM050**  
**0.5m BOOM ARM**  
**(3mm WALL THICKNESS)**

SWL 50kg

**3mm WALL BOOM ARM LOAD POINT INFORMATION**

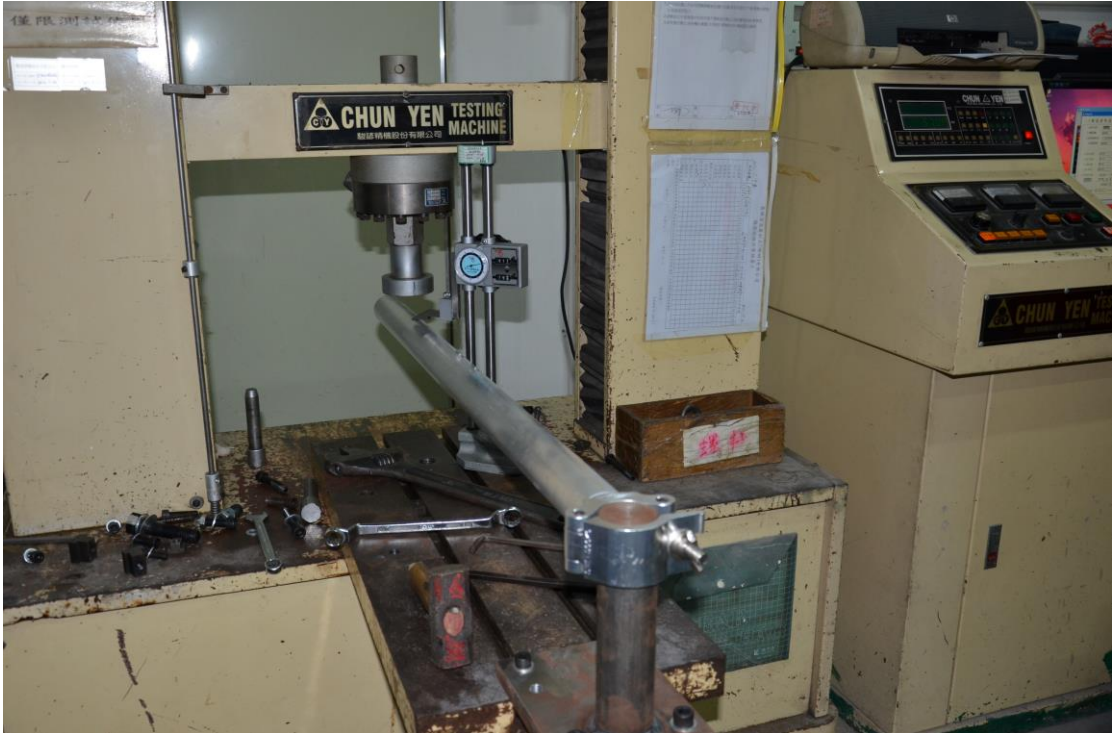
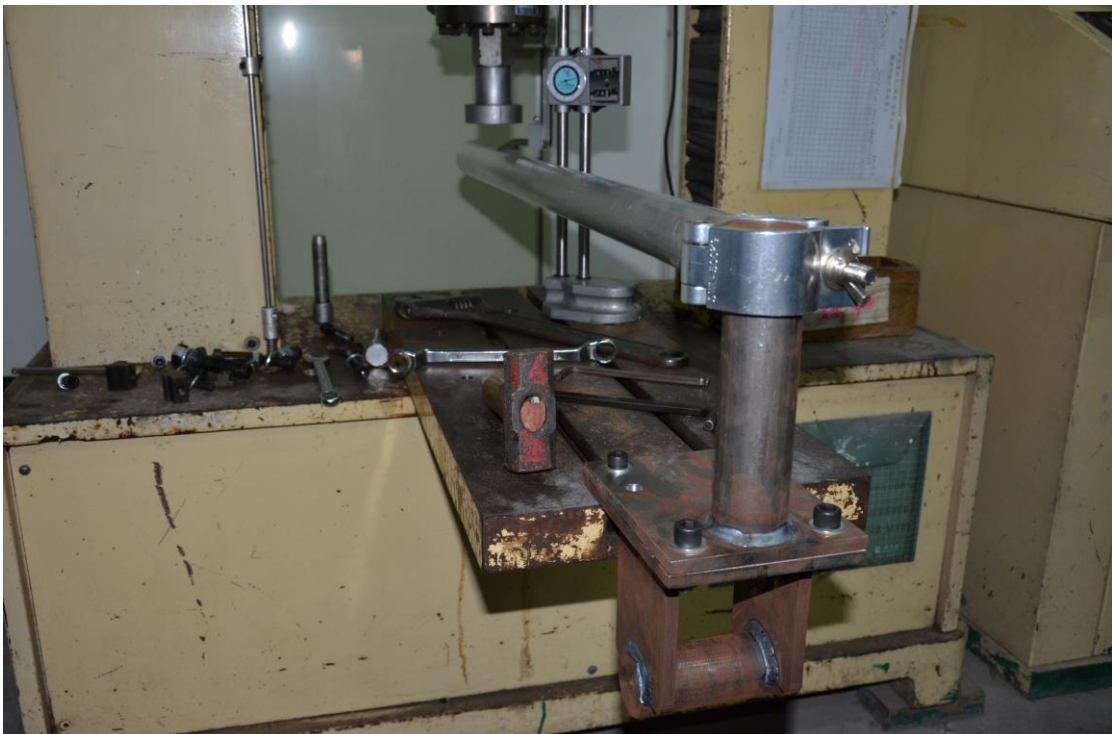
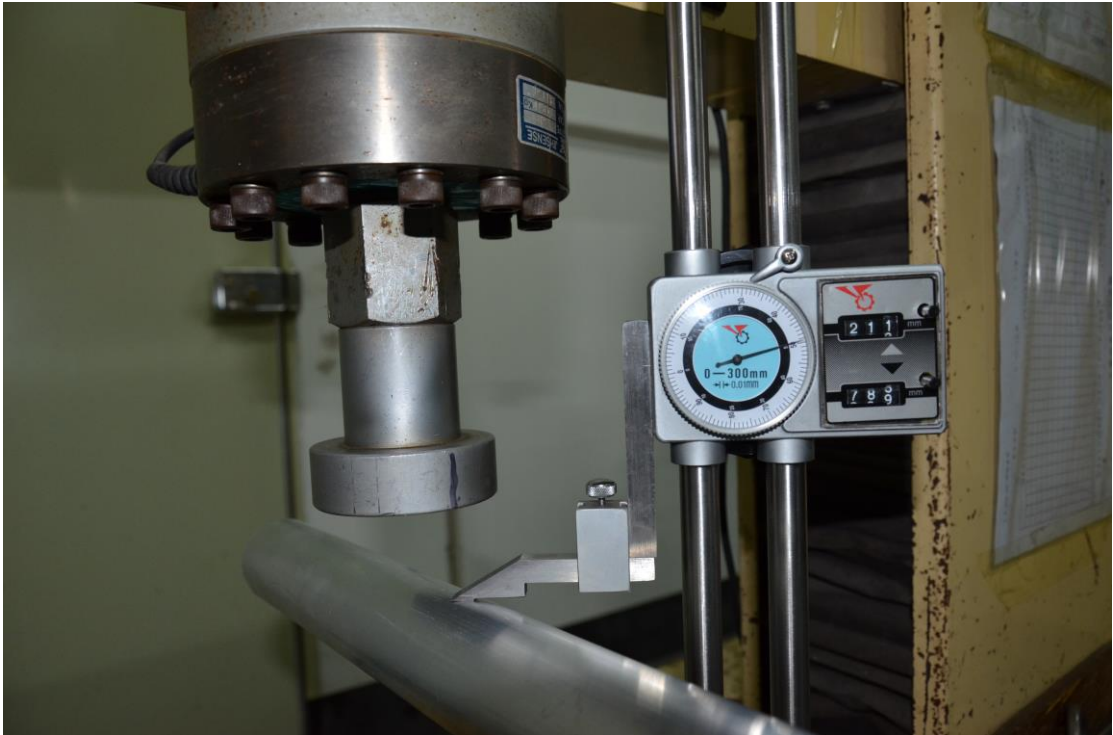
Below picture for show the statement of the conditions of testing

Before apply a test load, distance between plate and the end of tube is 211.5mm

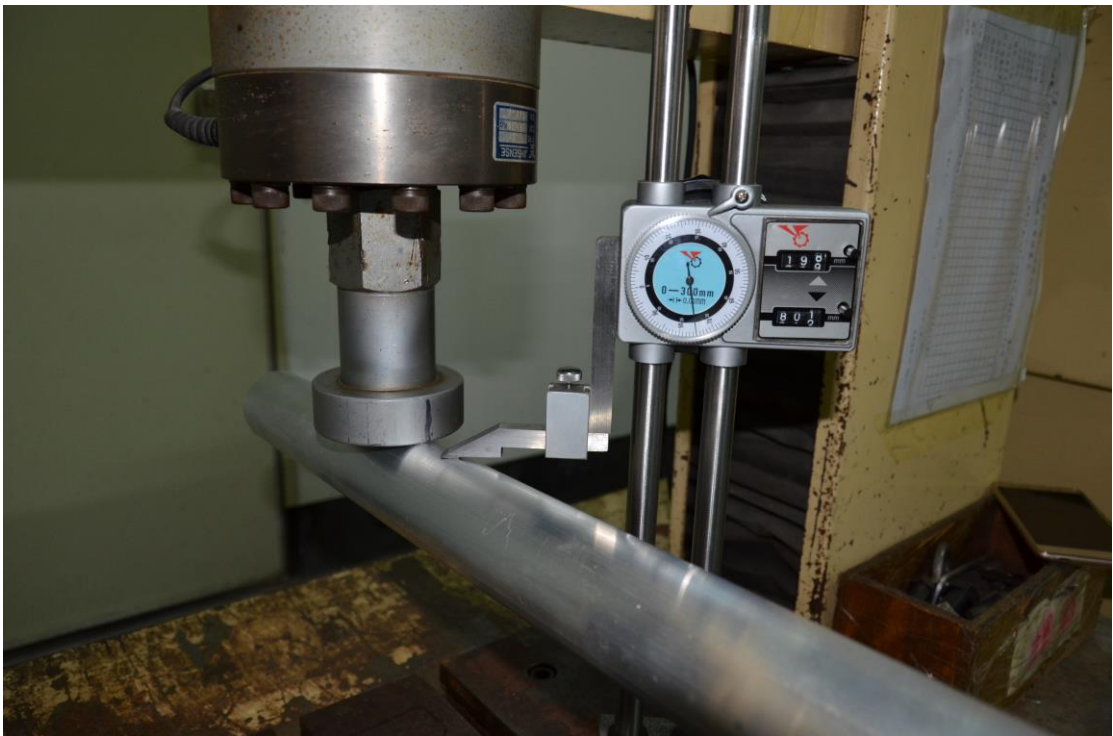
Apply a test load of 37.5kg

Distance is 198.75mm after loaded deformation of the specimen at five minutes

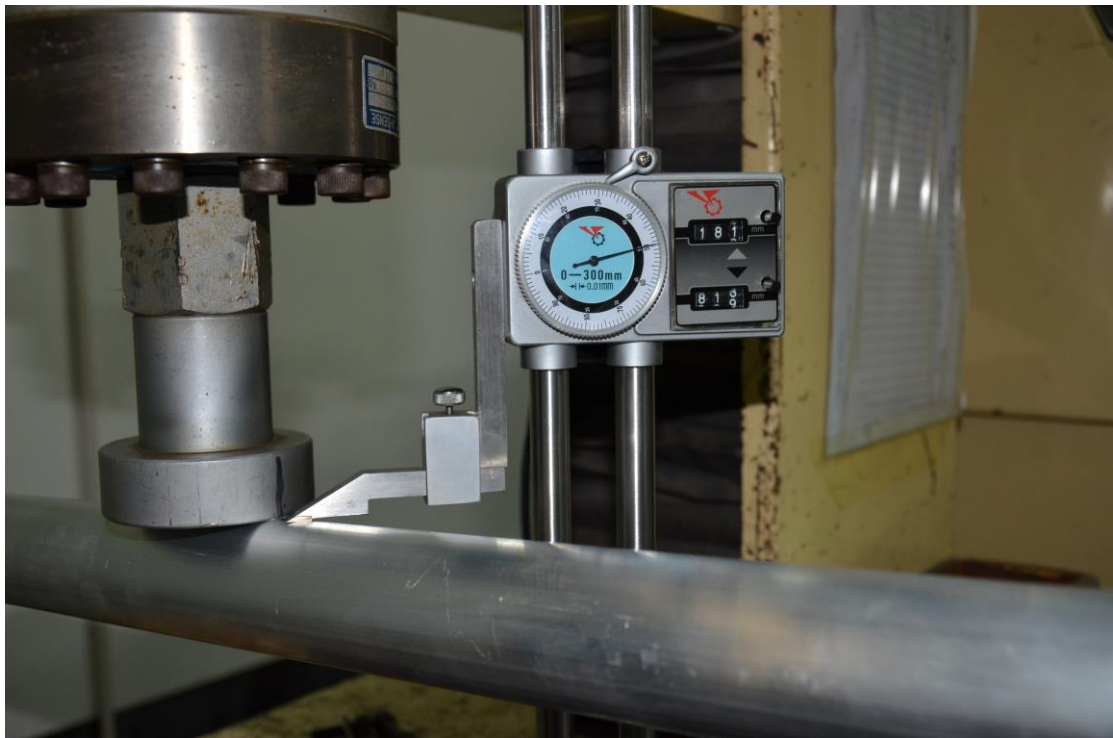
Apply a test load of 75kg

Distance is 181.5mm after loaded deformation of the specimen at five minutes

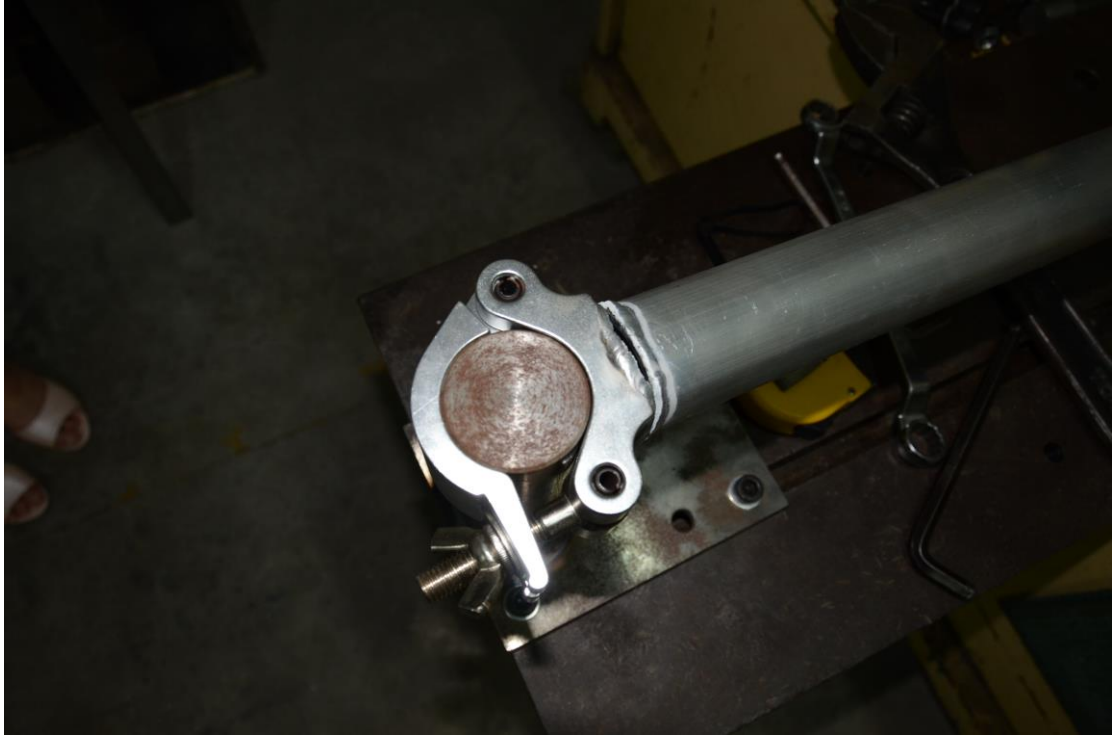
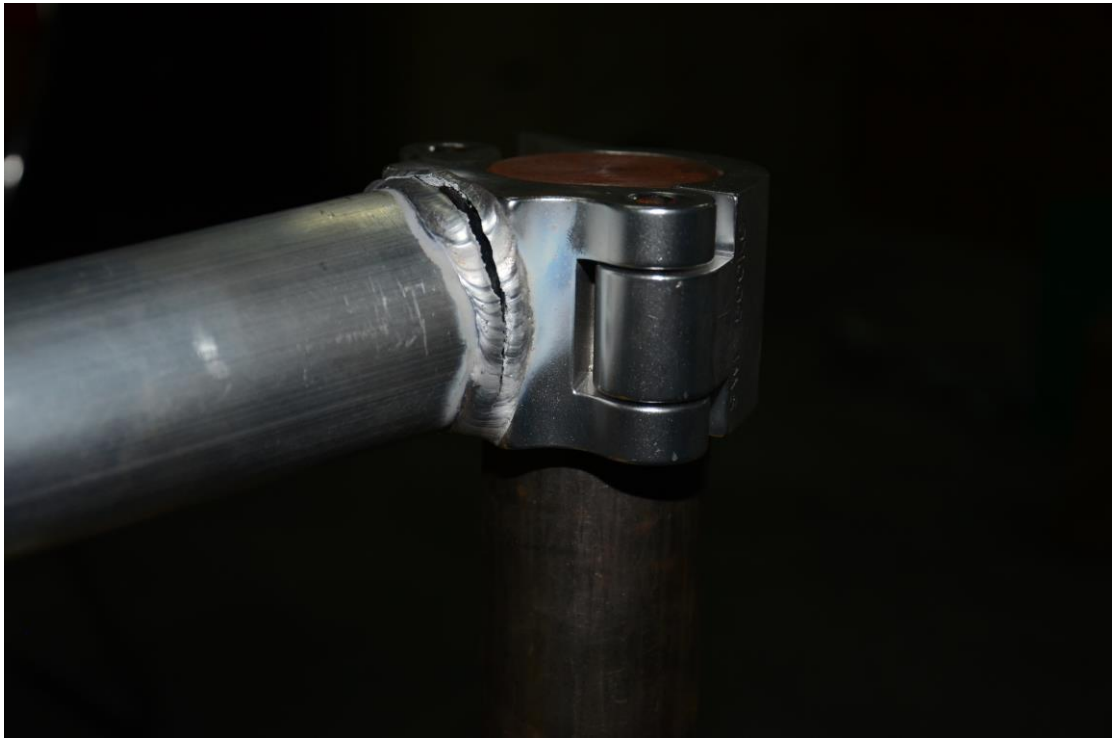
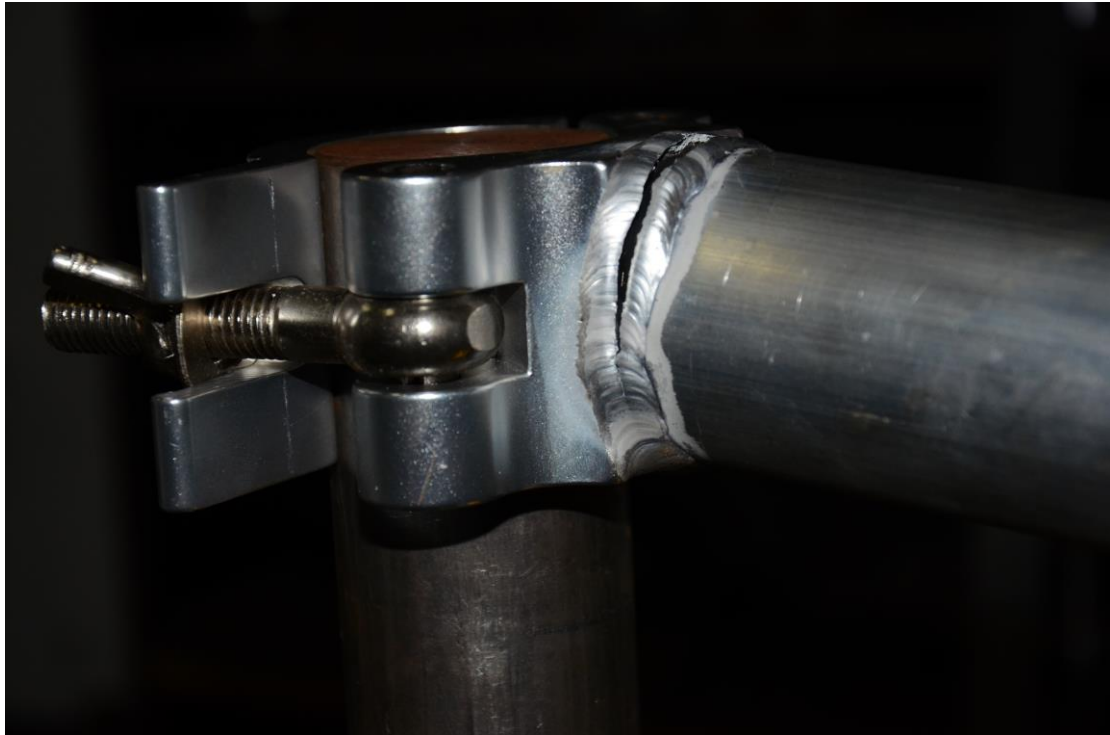
Apply a test load of 8000kg , the tube broken once at 202.1kg.

The tube fracture at weld, others No obvious deformation

Load Step	Load(N)	Loaded Deformation(mm)	Time Held(s)	Pass/Fail	Unloaded Deformation
1	375	12.75	300	Pass	No obvious deformation
2	750	30	300	Pass	No obvious deformation
Test until failure	80000	78.1	300	Fail	Tube fracture deformation

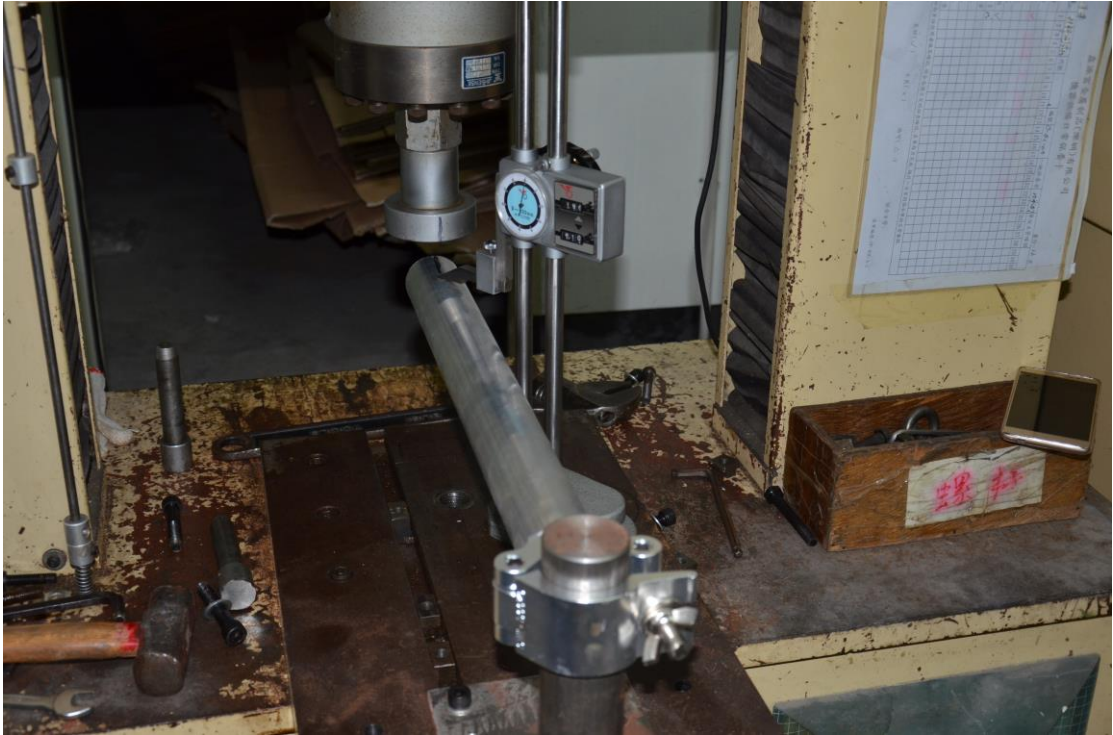
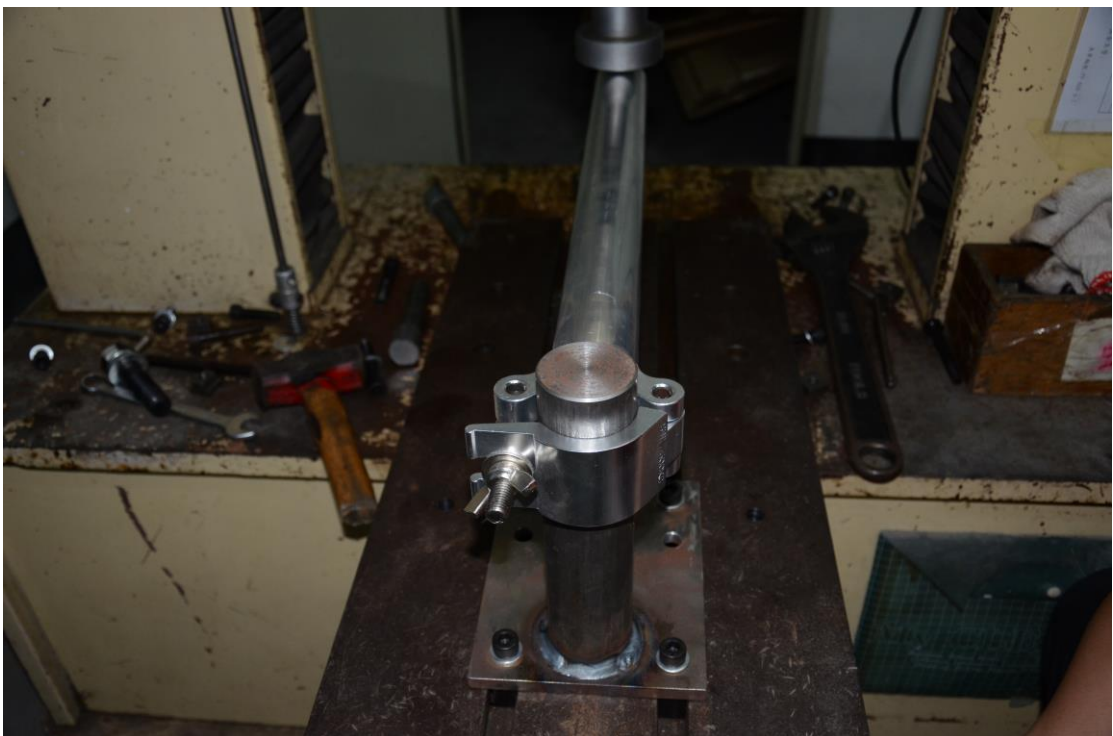
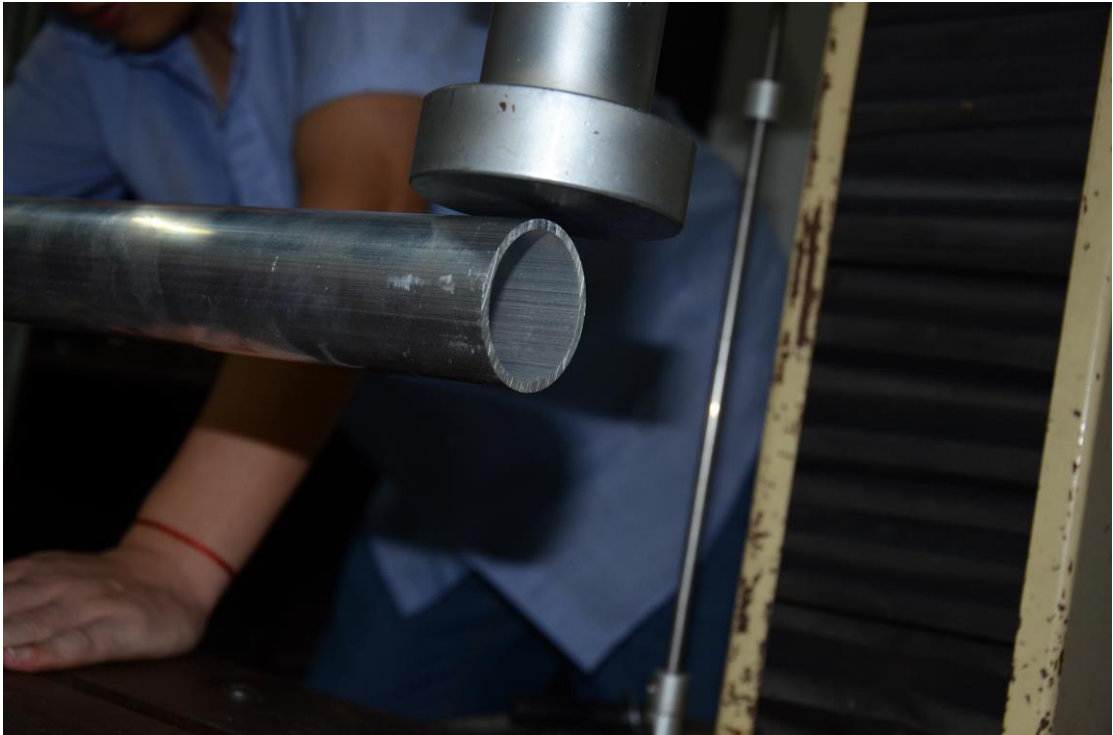
Below picture for show the statement of the conditions of testing

**Before apply a test load, distance between plate and the end of tube is 190.9mm**

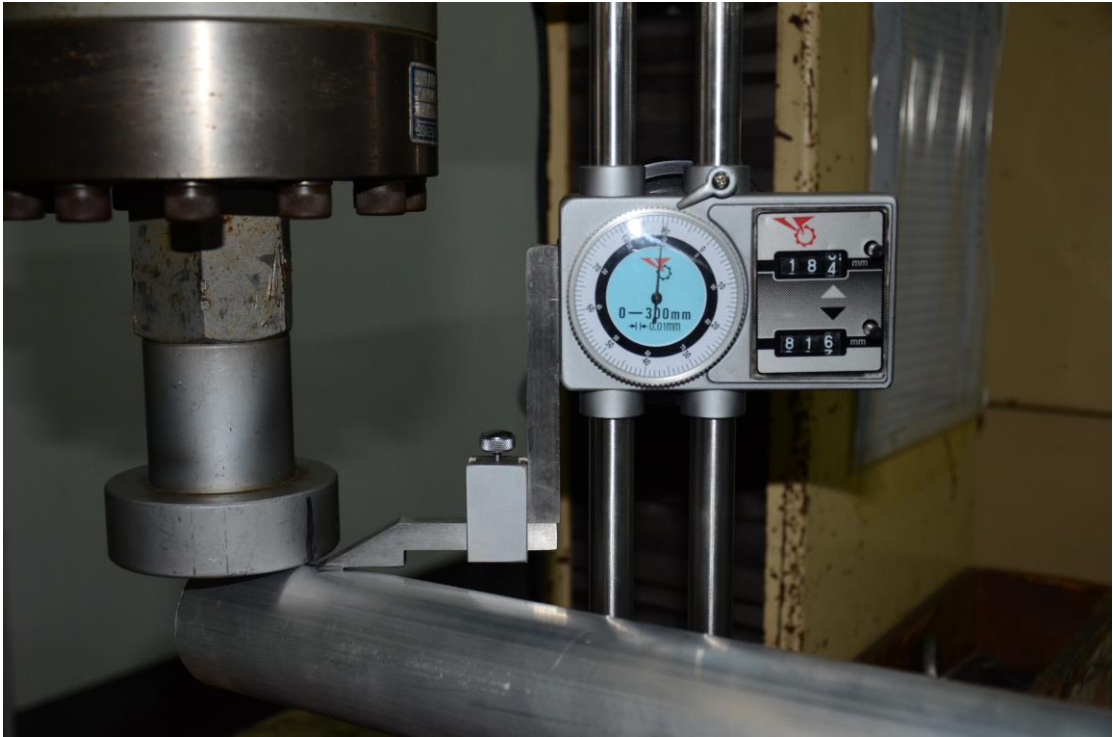
Apply a test load of 75kg

**Distance is 183.9mm after loaded deformation of the specimen at five minutes**

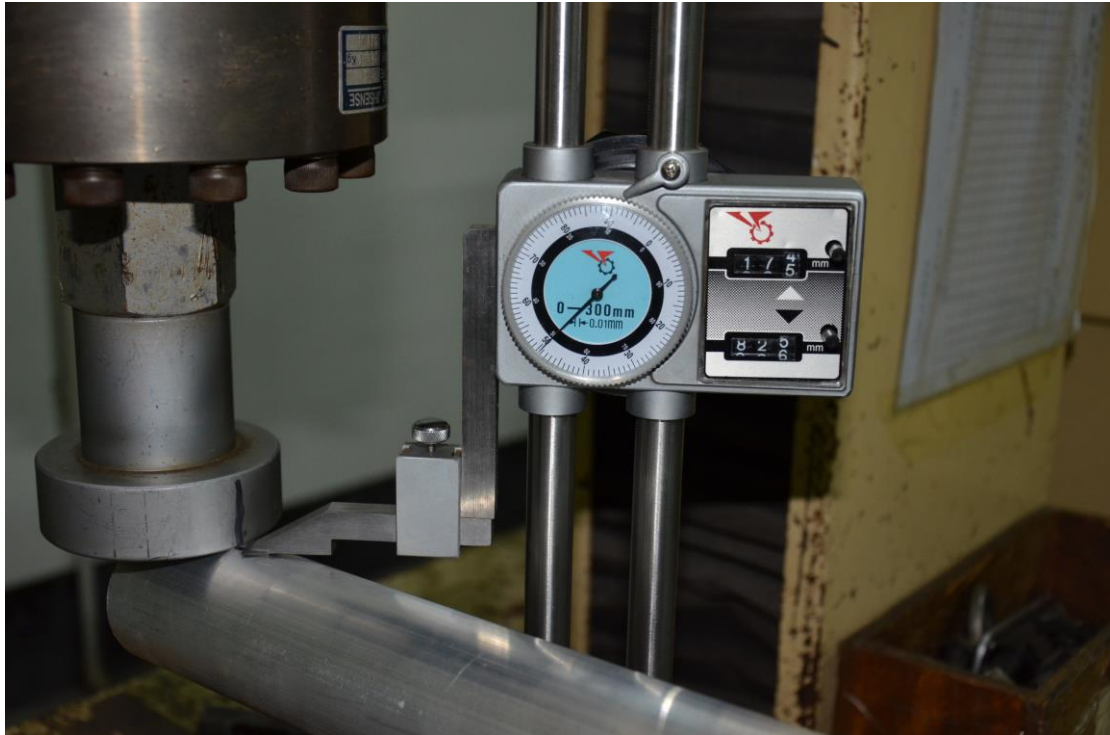
Apply a test load of 150kg

**Distance is 174.5mm after loaded deformation of the specimen at five minutes**

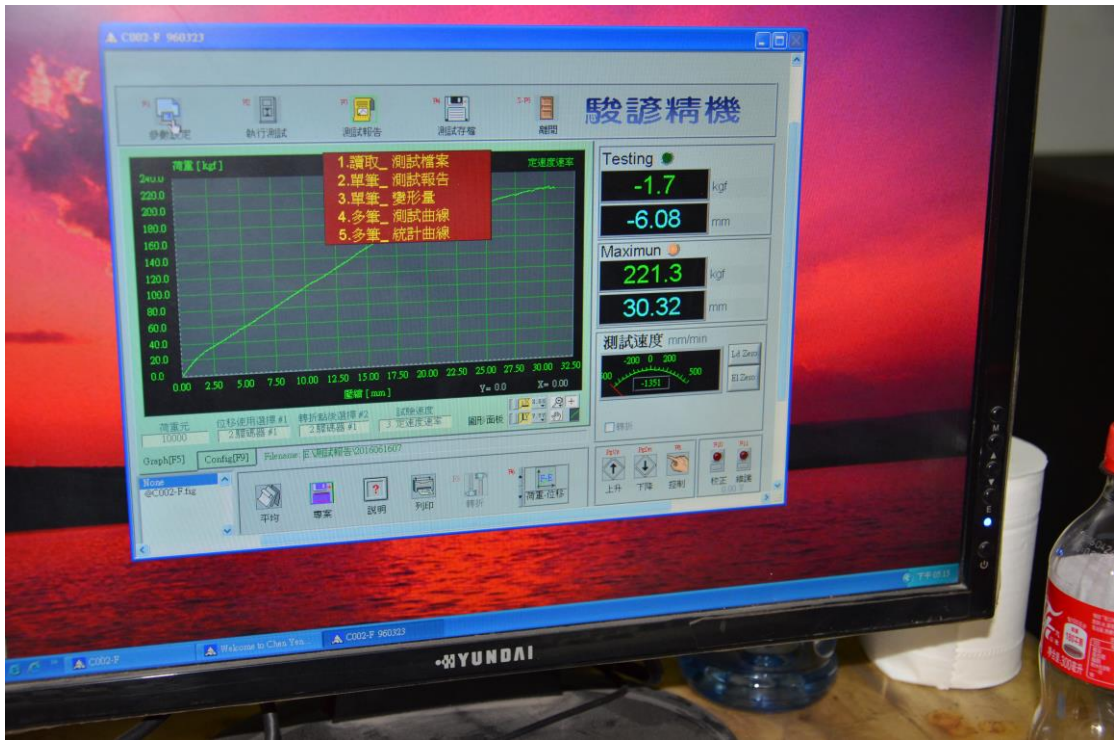
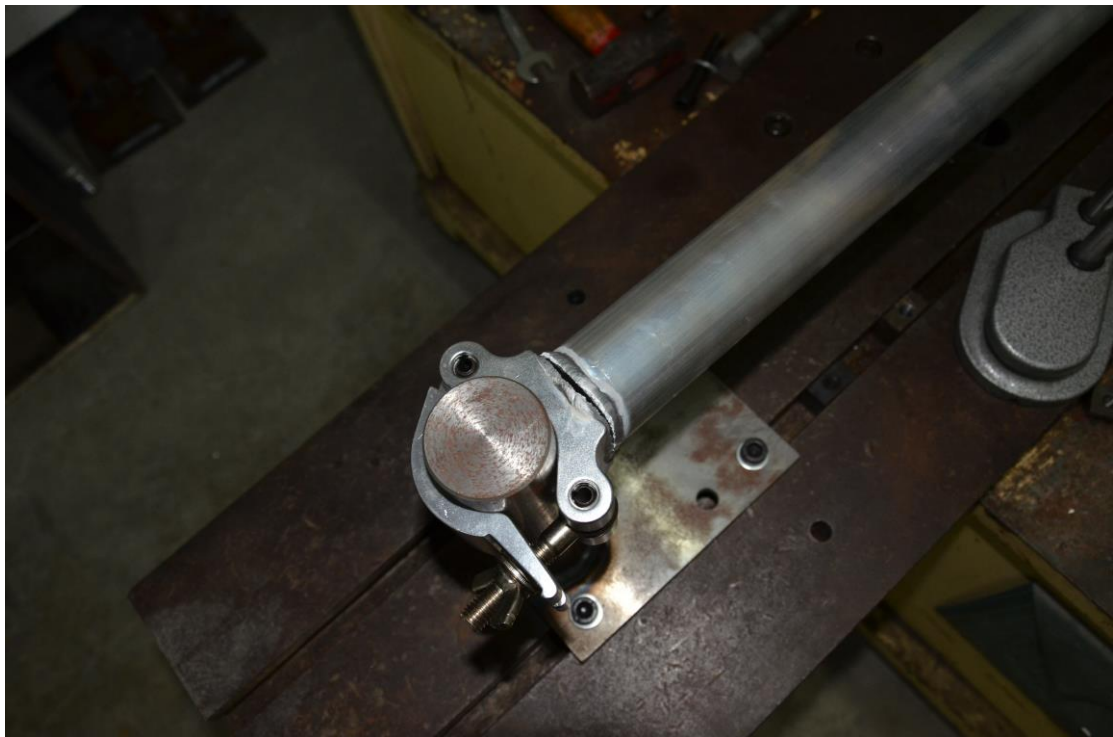
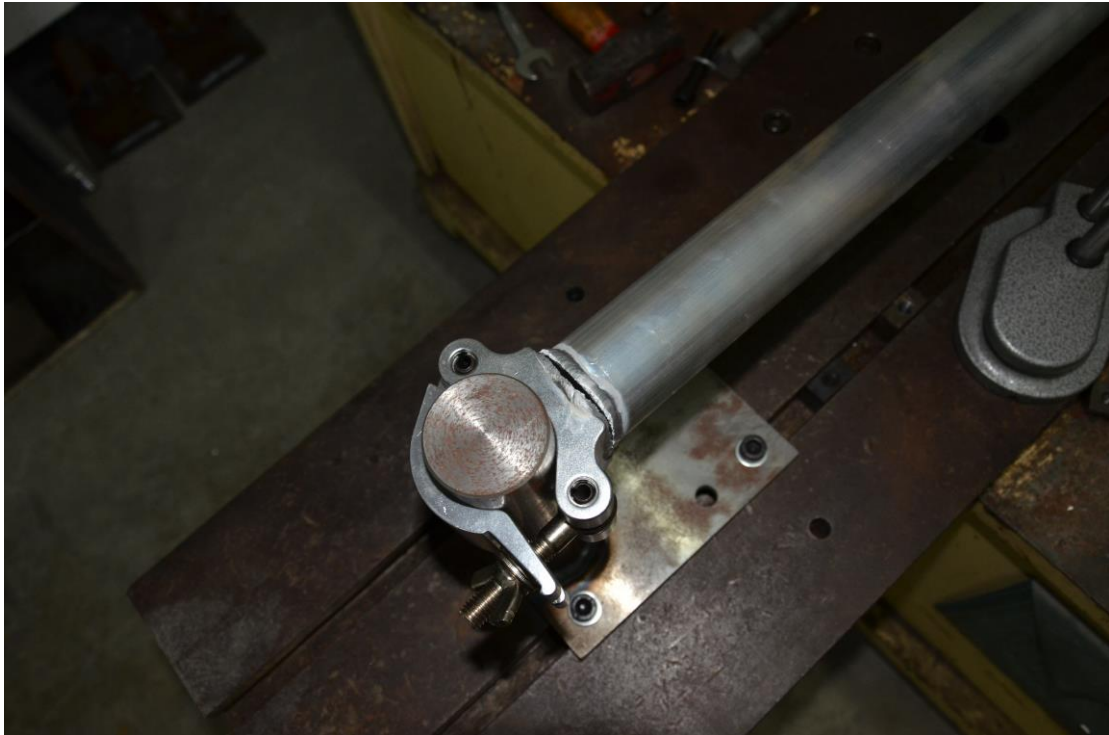
**Apply a test load of 8000kg , the tube broken once at 221.3kg.**

The tube fracture at weld, others No obvious deformation

Load Step	Load(N)	Loaded Deformation(mm)	Time Held(s)	Pass/Fail	Unloaded Deformation
1	750	7.0	300	Pass	No obvious deformation
2	1500	16.4	300	Pass	No obvious deformation
Test until failure	80000	33.2	300	Fail	Tube fracture deformation

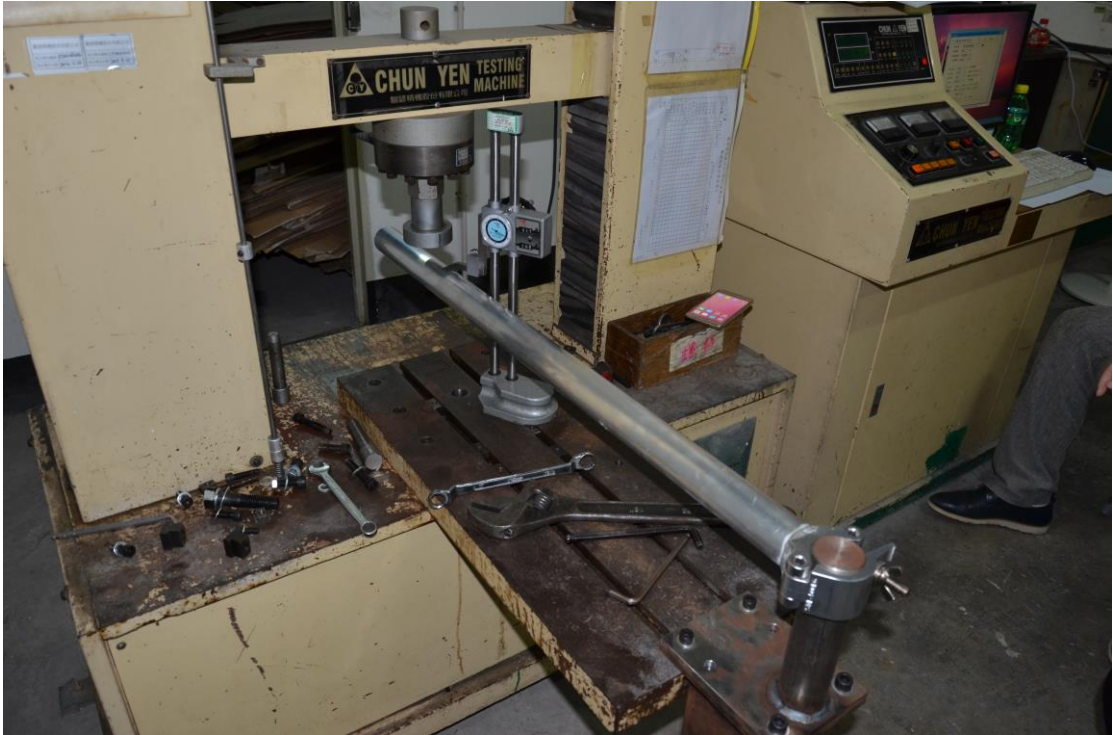
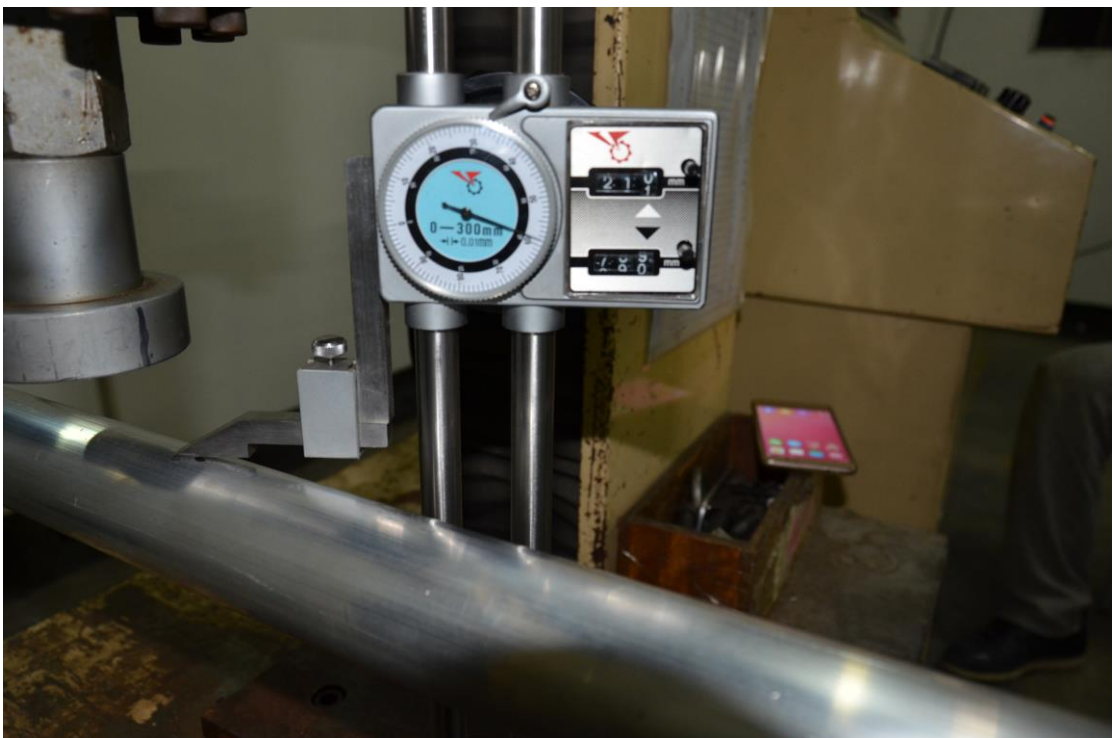
Below picture for show the statement of the conditions of testing

Before apply a test load, distance between plate and the end of tube is 210.6mm

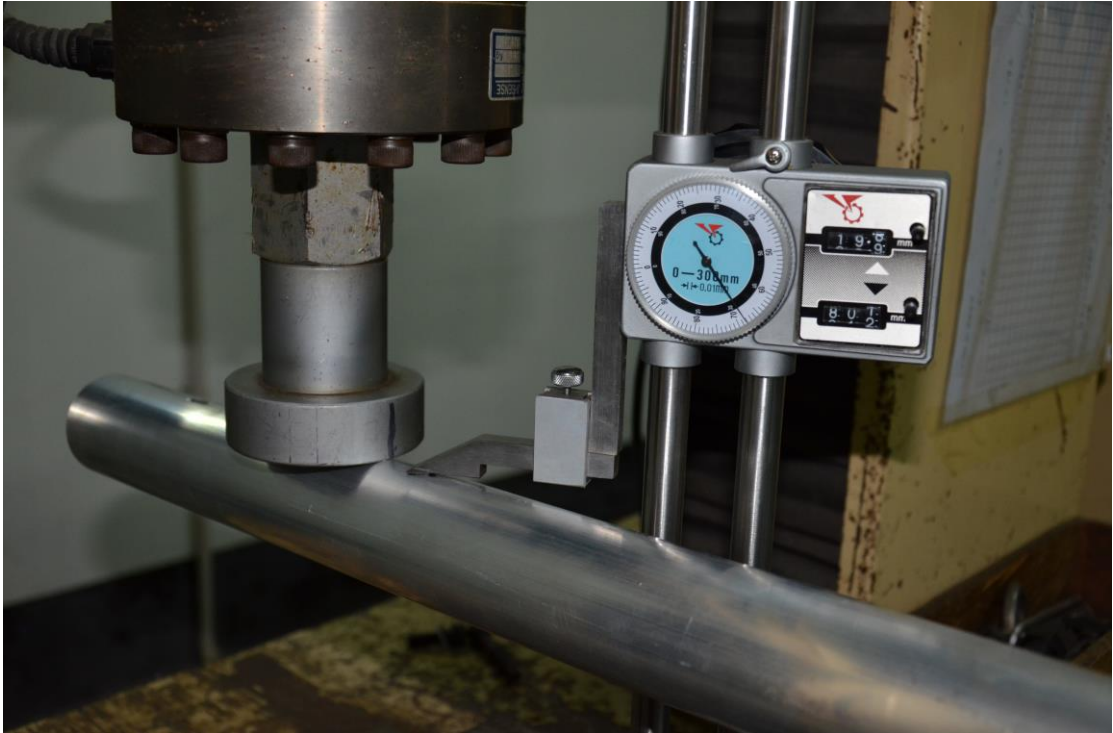
**Apply a test load of 37.5kg**

**Distance is 198.7mm after loaded deformation of the specimen at five minutes**

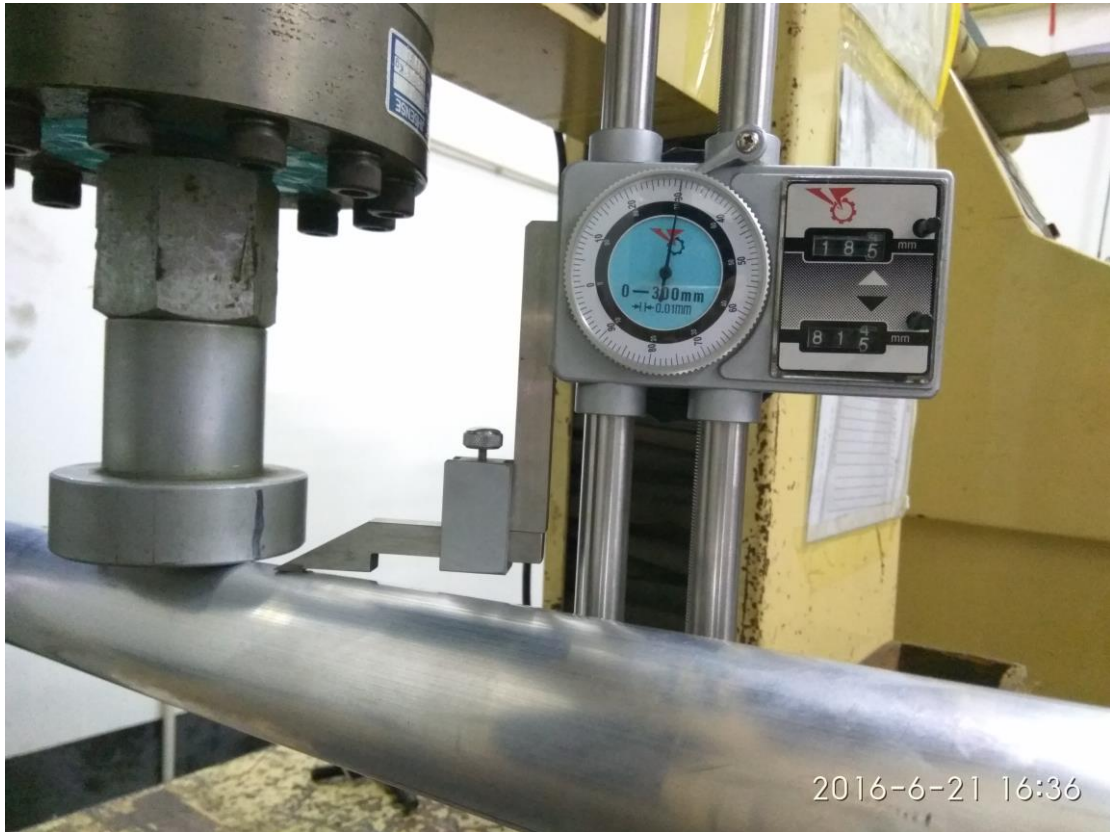
Apply a test load of 75kg

Distance is 184.3mm after loaded deformation of the specimen at five minutes

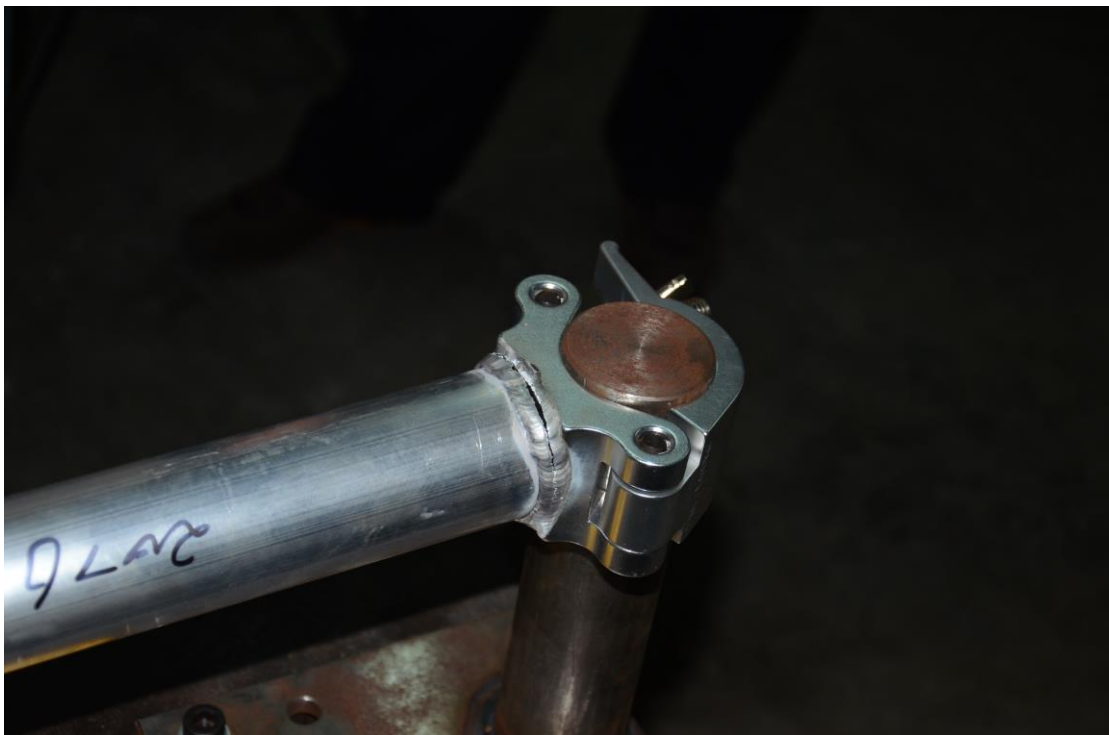
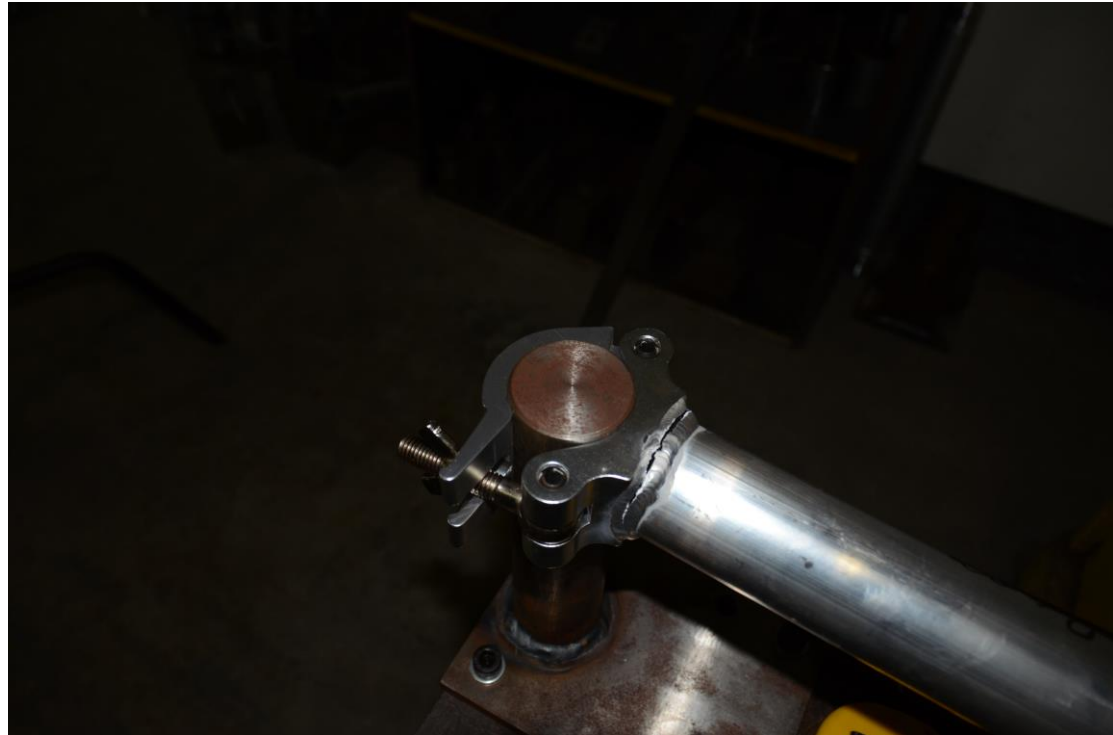
Apply a test load of 8000kg , the tube broken once at 151.6kg.

The tube fracture at weld, others No obvious deformation

Load Step	Load(N)	Loaded Deformation(mm)	Time Held(s)	Pass/Fail	Unloaded Deformation
1	375	11.9	300	Pass	No obvious deformation
2	750	26.3	300	Pass	No obvious deformation
Test until failure	80000	41.67	300	Fail	Tube fracture deformation

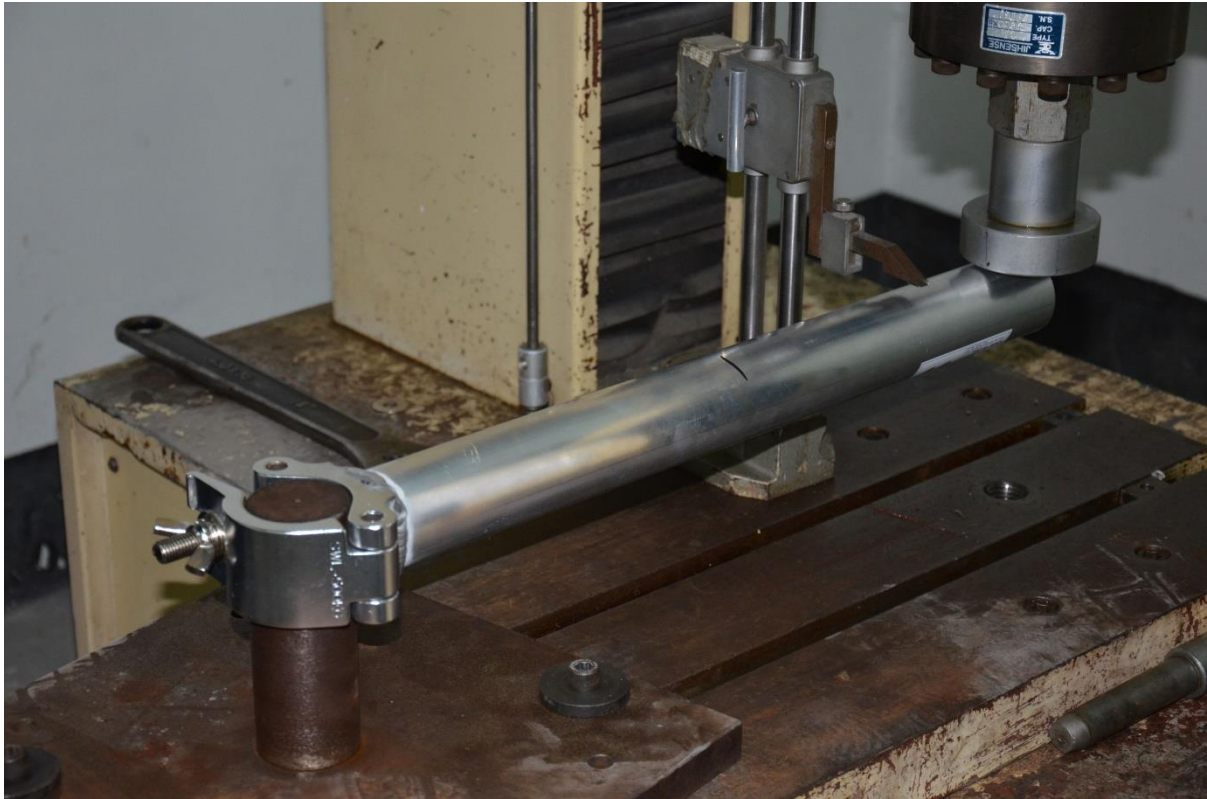
The below picture shows the conditions of testing

Load (kg)	Load (kN)	Deflection (mm)
50	0.5	5.05
75	0.75	7.60

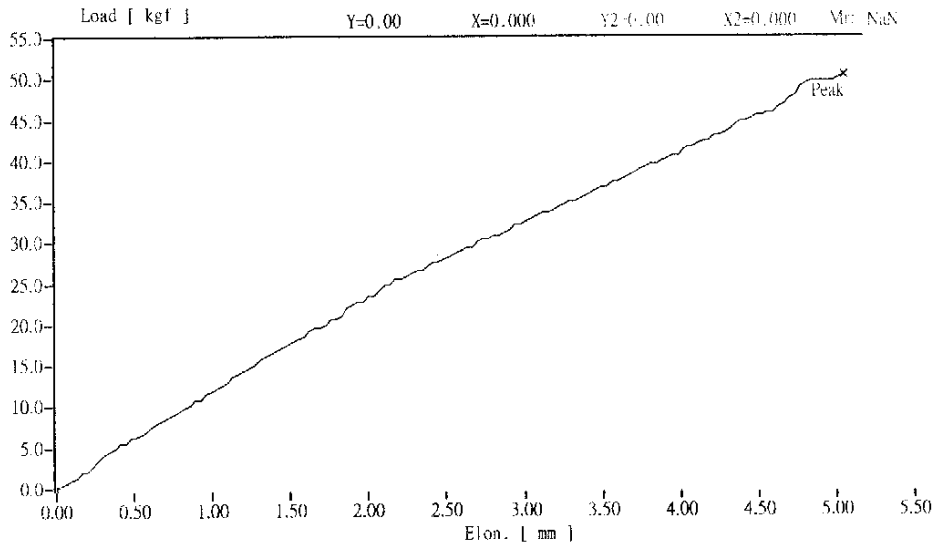
Apply a test load of 50kg

Load(kgf)	Elong.(mm)	Stress(kgf/mm <sup>2</sup> )	Strain(%)
Peak	50.4	5.05	Inf	1.01
Break	50.4	5.05	Inf	1.01
Yield	0.0	0.00	NaN	0.00

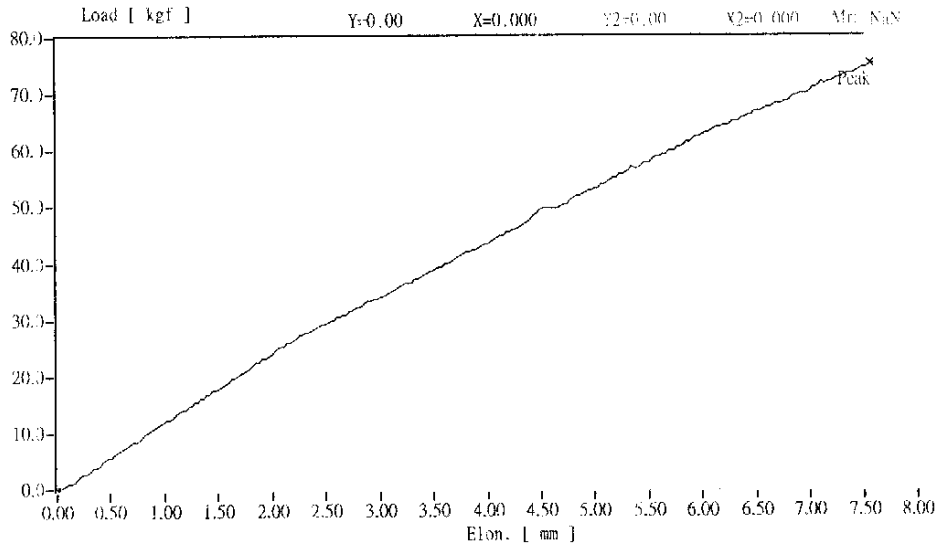
Apply a test load of 75kg

Load(kgf)	Elon.(mm)	Stress(kgf/mm <sup>2</sup> )	Strain(%)
Peak	75.2	7.57	Inf	1.51
Break	75.2	7.60	Inf	1.52
Yield	0.0	0.00	NaN	0.00
