**Structural Report**  
Rev 01

**Endplate-QLJZ15**  
Suspension point F34

**23279-A**

**Global Truss**  
Furong Industrial Area  
Shajing Town

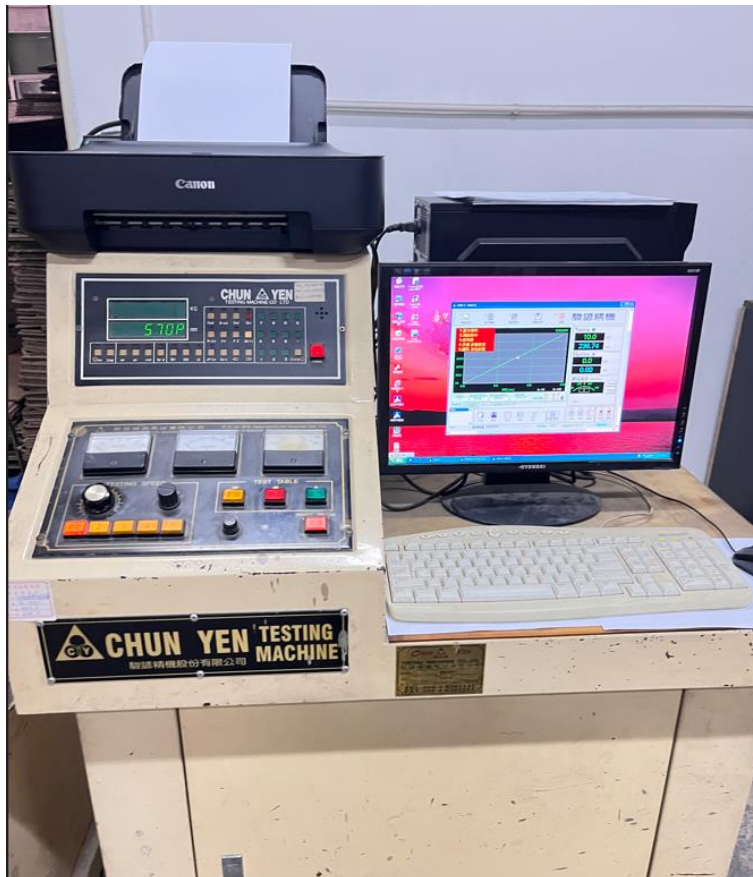
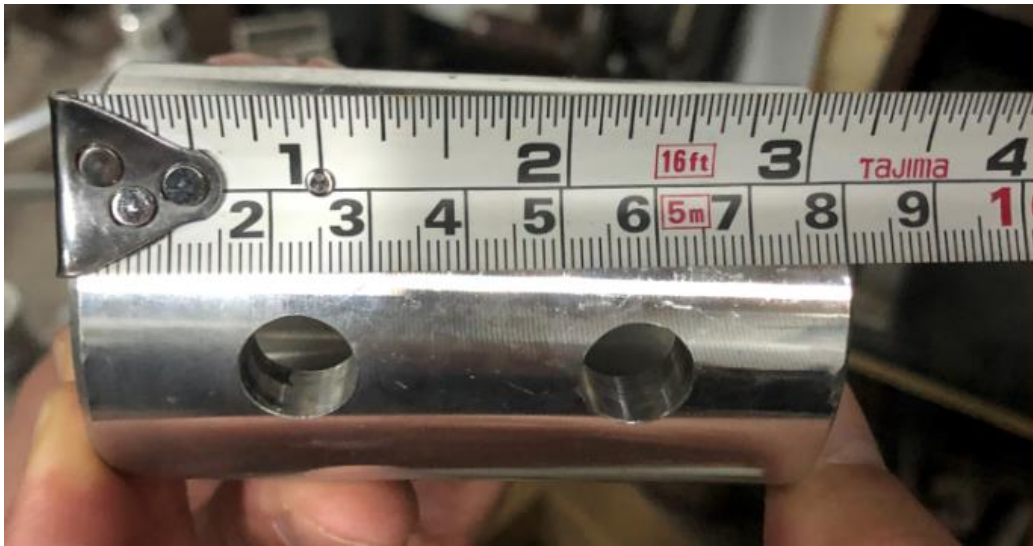
Below picture for show the statement of the conditions of testing.

ST5019 length is 80mm

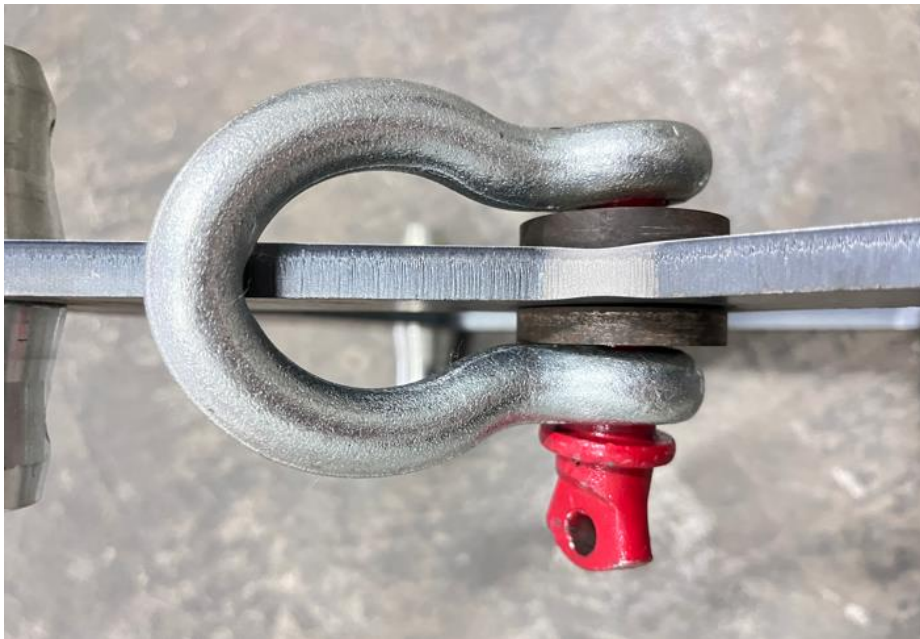
**The Plate No obvious deformation**

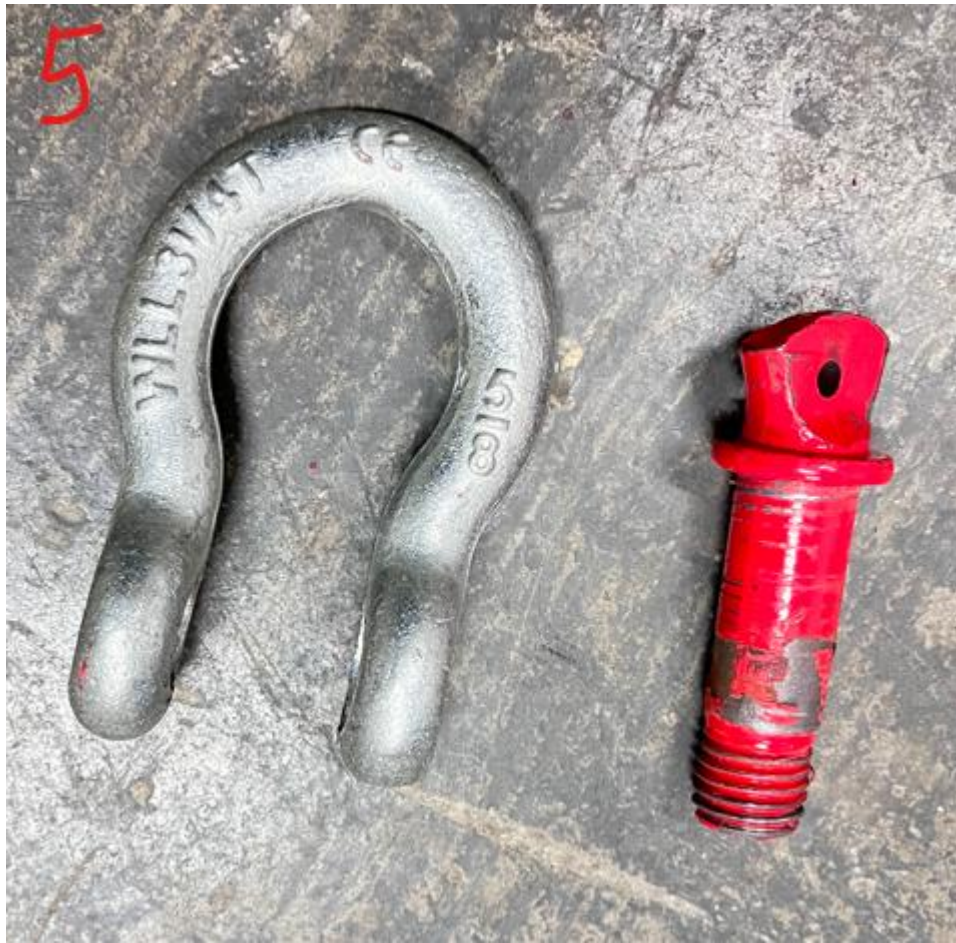
D-shackle obvious deformation

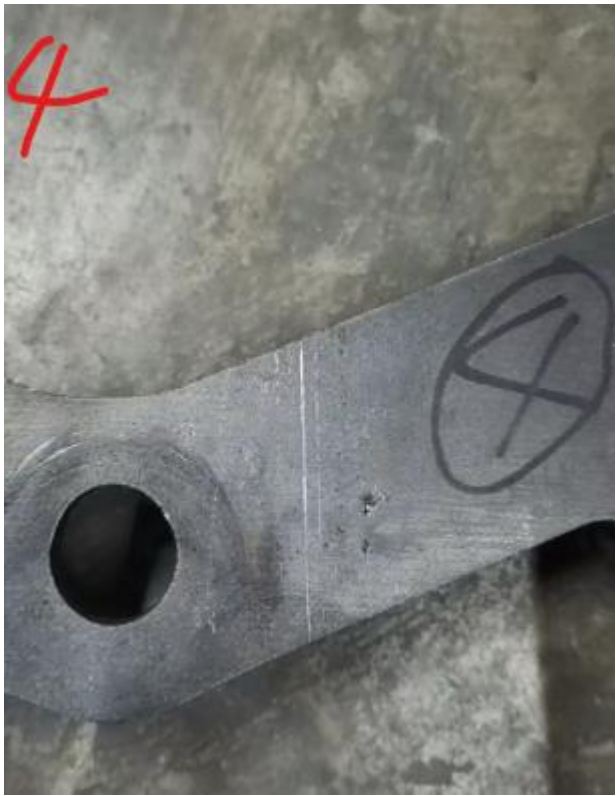
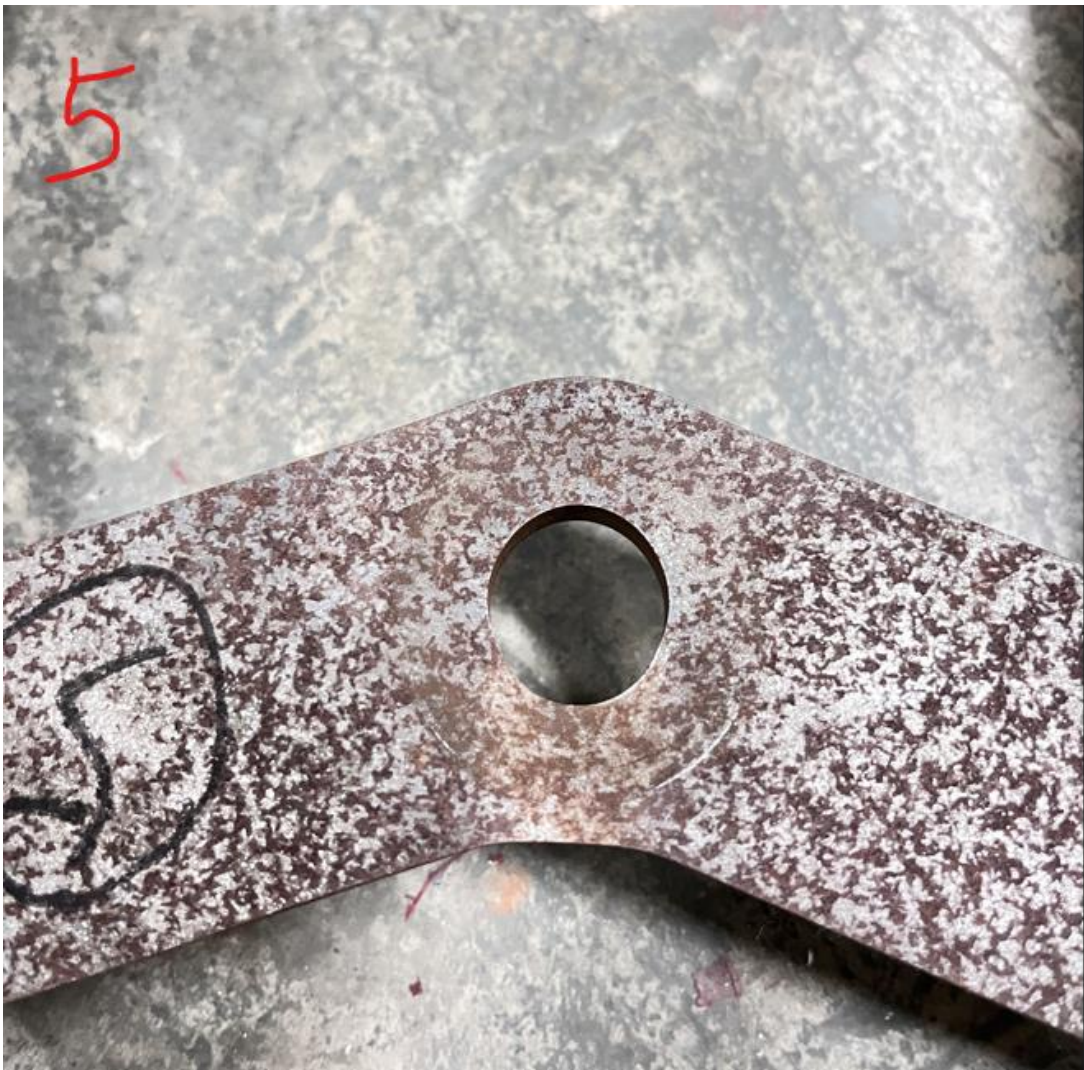
# The hole of the plate obvious deformation

The tests show that plastic deformation occurs at a load of 8000 kg, but there is no failure of the system so far.

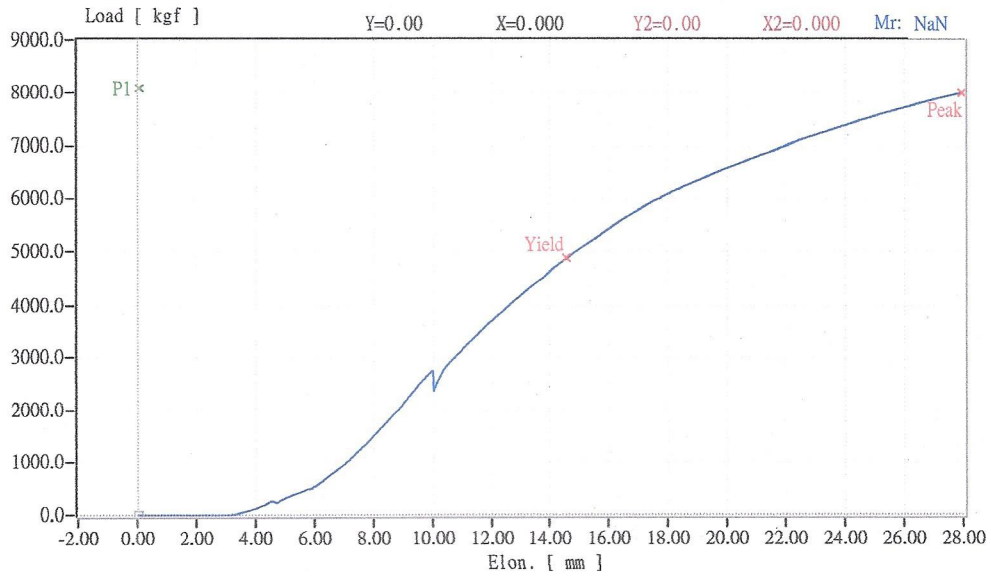
1.Customer : 鑫源富金屬製品（深圳）有限公司  
2.Operator :  
3.Lot No. : 20230302001  
4.Date : 2023年3月20日  
5.Time : 上午 08:56:11  
6.Temperature: 25C  
7.Speed : 20.00mm/min  
8.Test Style : Tension Test  
9.Standard :  
10.Specimen : QLJZ15 T5  
11.Spec.Length : 60.000mm  
12.Spec.Style : Random  
13.Spec.Area : 301.5929mm<sup>2</sup>  
14.Total Energy: 114378kgf·mm  
15.Young's Modu. : 98.636kgf/mm<sup>2</sup>  
16.Notice :  
17.FileName: E:\測試報告\20230302001

Load(kgf)	Elon.(mm)	Stress(kgf/mm <sup>2</sup> )	Strain(%)
Peak	8002.8	27.94	26.535	46.57
Break	8002.8	27.94	26.535	46.57
Yield	4876.1	14.53	16.168	24.22
